COMBUSTION TURBINE ROTOR ASSESSMENT

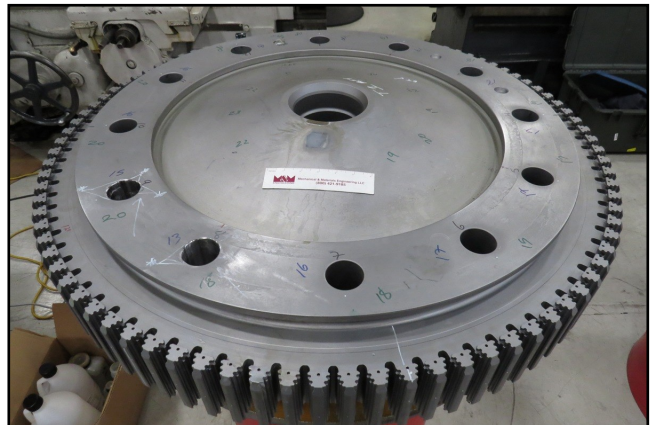
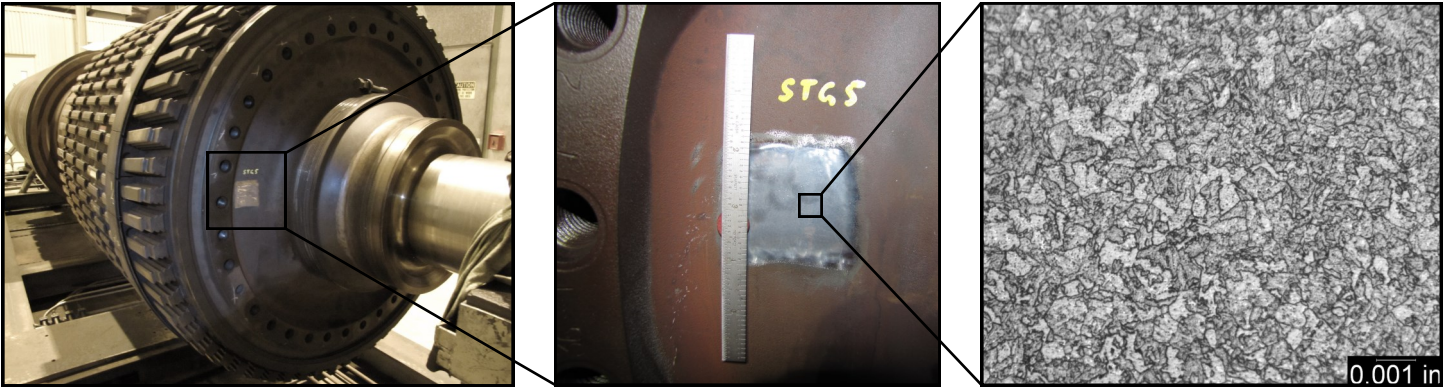
Examining a component's microstructure can reveal deterioration from environmental degradation, creep damage, fatigue cracking, and thermal aging. Accurate assessment provides important data for determining equipment condition and remaining life. Replicas are analyzed for metallurgical and manufacturing defects and external surface discontinuities.

When examining large components that cannot be easily moved, in-place metallography is used for microstructural and crack evaluation. In-place metallography, combined with replication, allows us to examine a component's microstructure without removing a sample from the component. The same techniques can be used on small specimens when standard preparation methods are difficult or impossible.
